DEPARTMENT OF THE ARMY
UNITED STATES ARMY AVIATION TEST BOARD
Fort Rucker, Alabama 36360

SUBJECT: ~~Letter Report~~ "Product Improvement Test, T53-L-11
Metal Spray Repaired Engine," ~~ADT&E~~ Project No.
5-0151-13, USATECOM Project No. 4-

ENGINEERING ANALYSIS

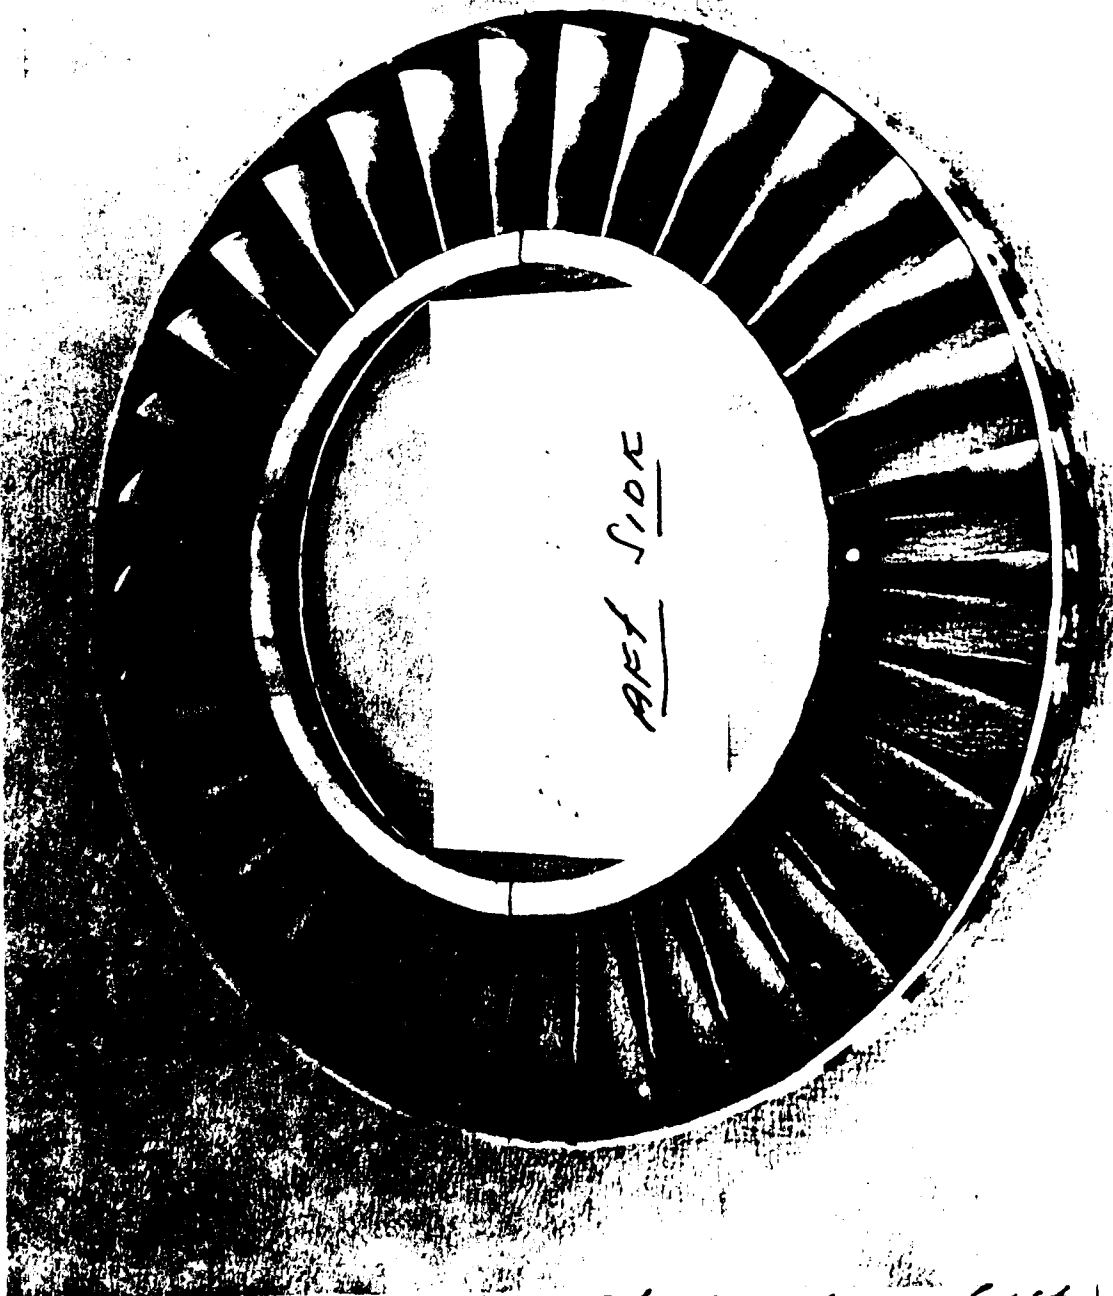
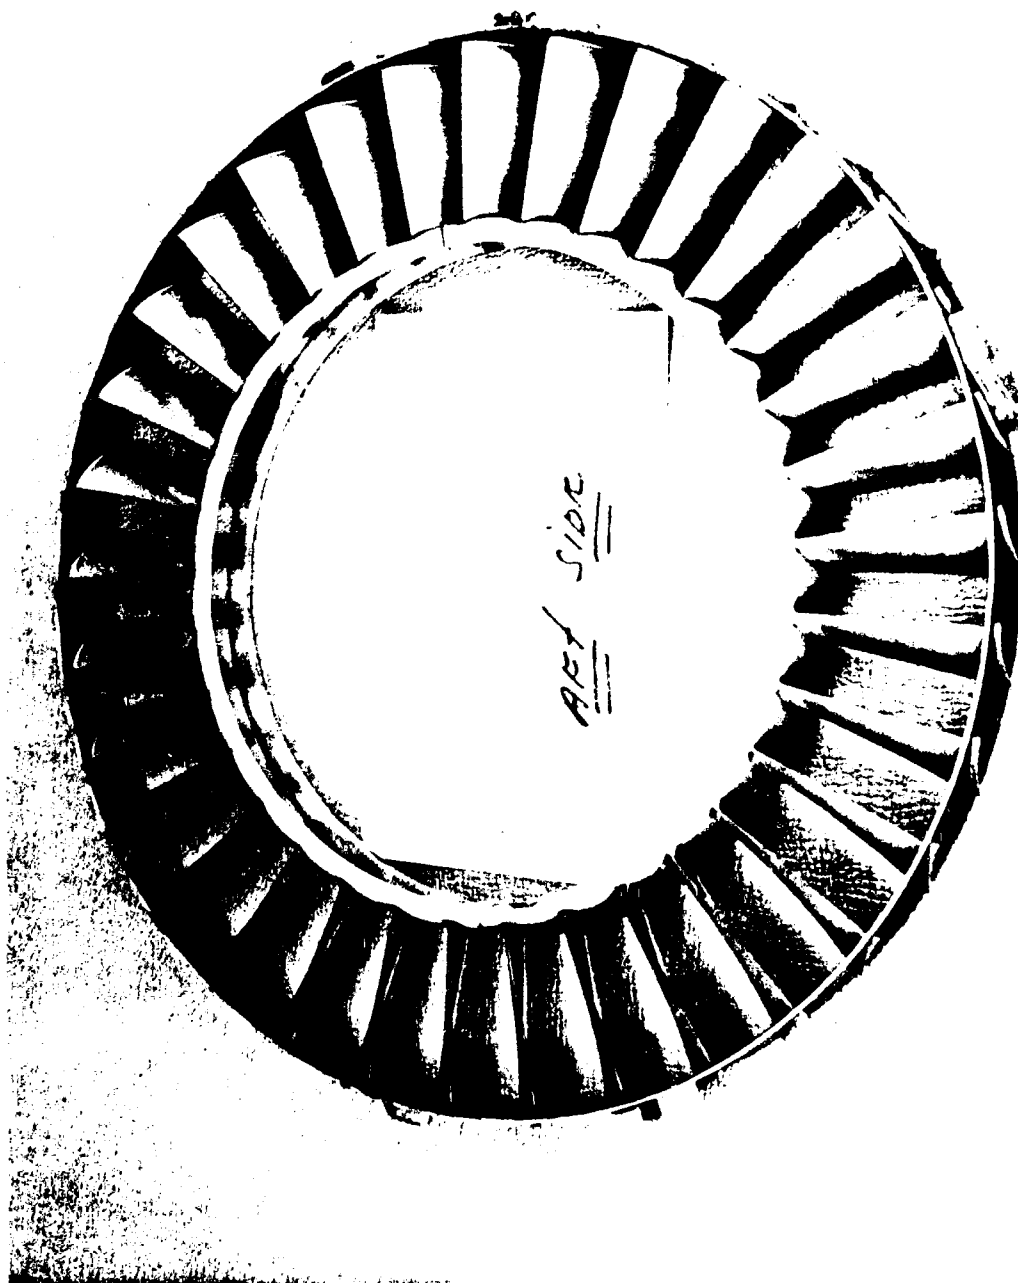
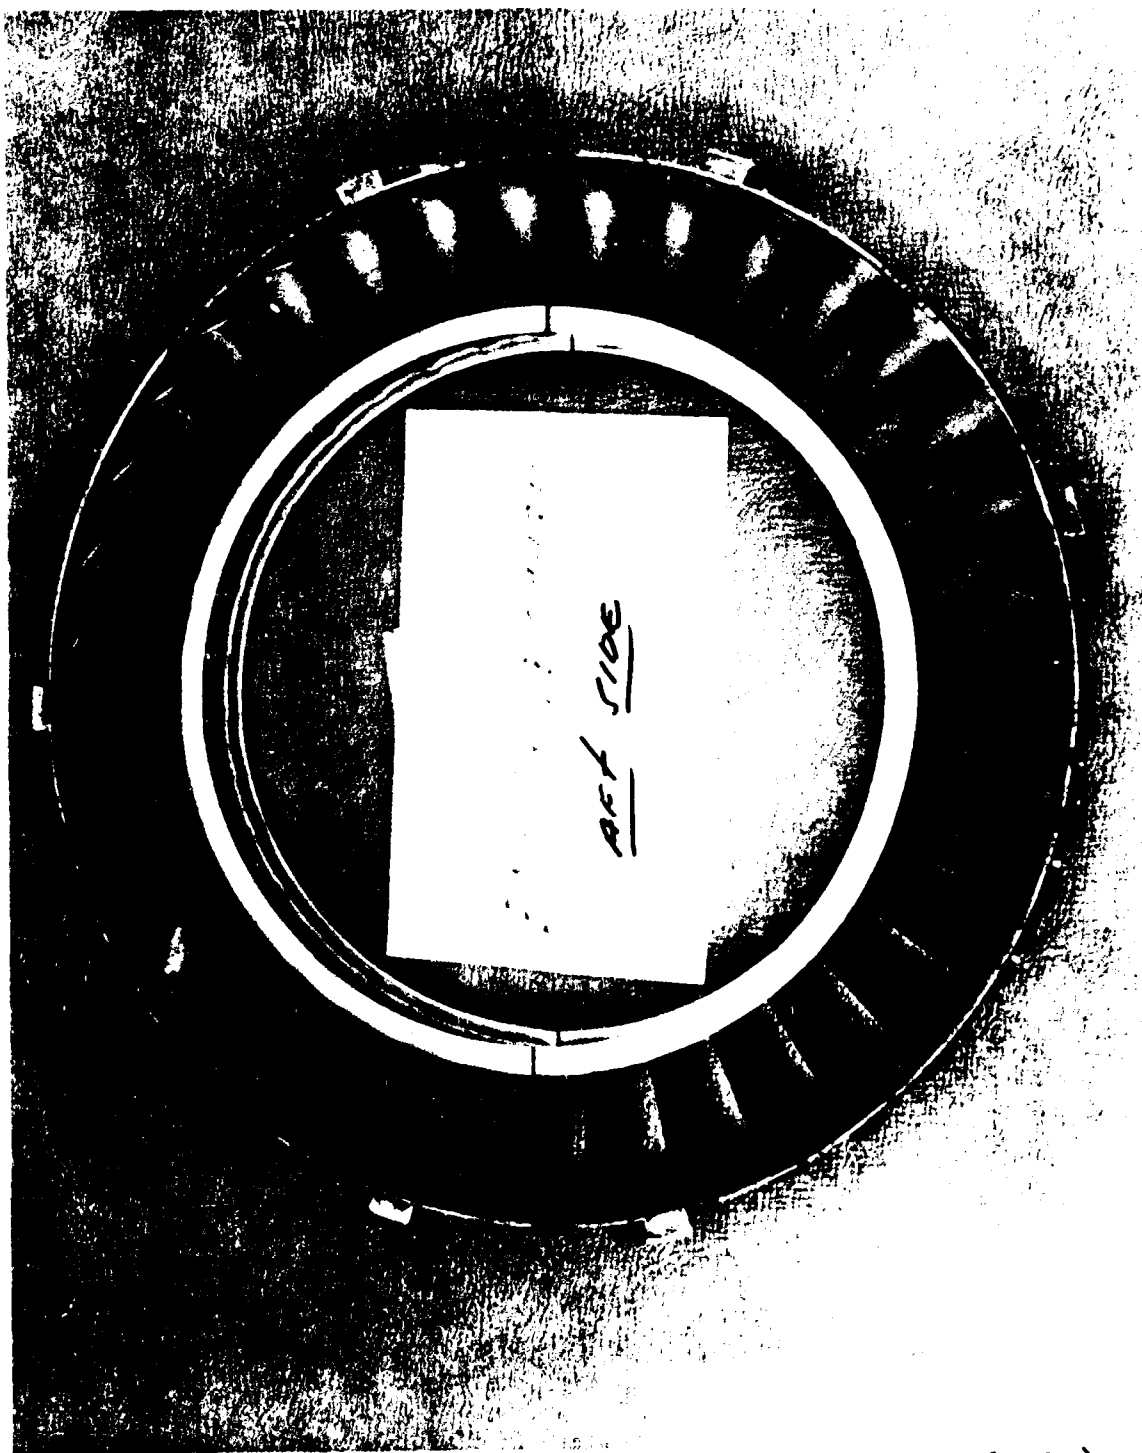
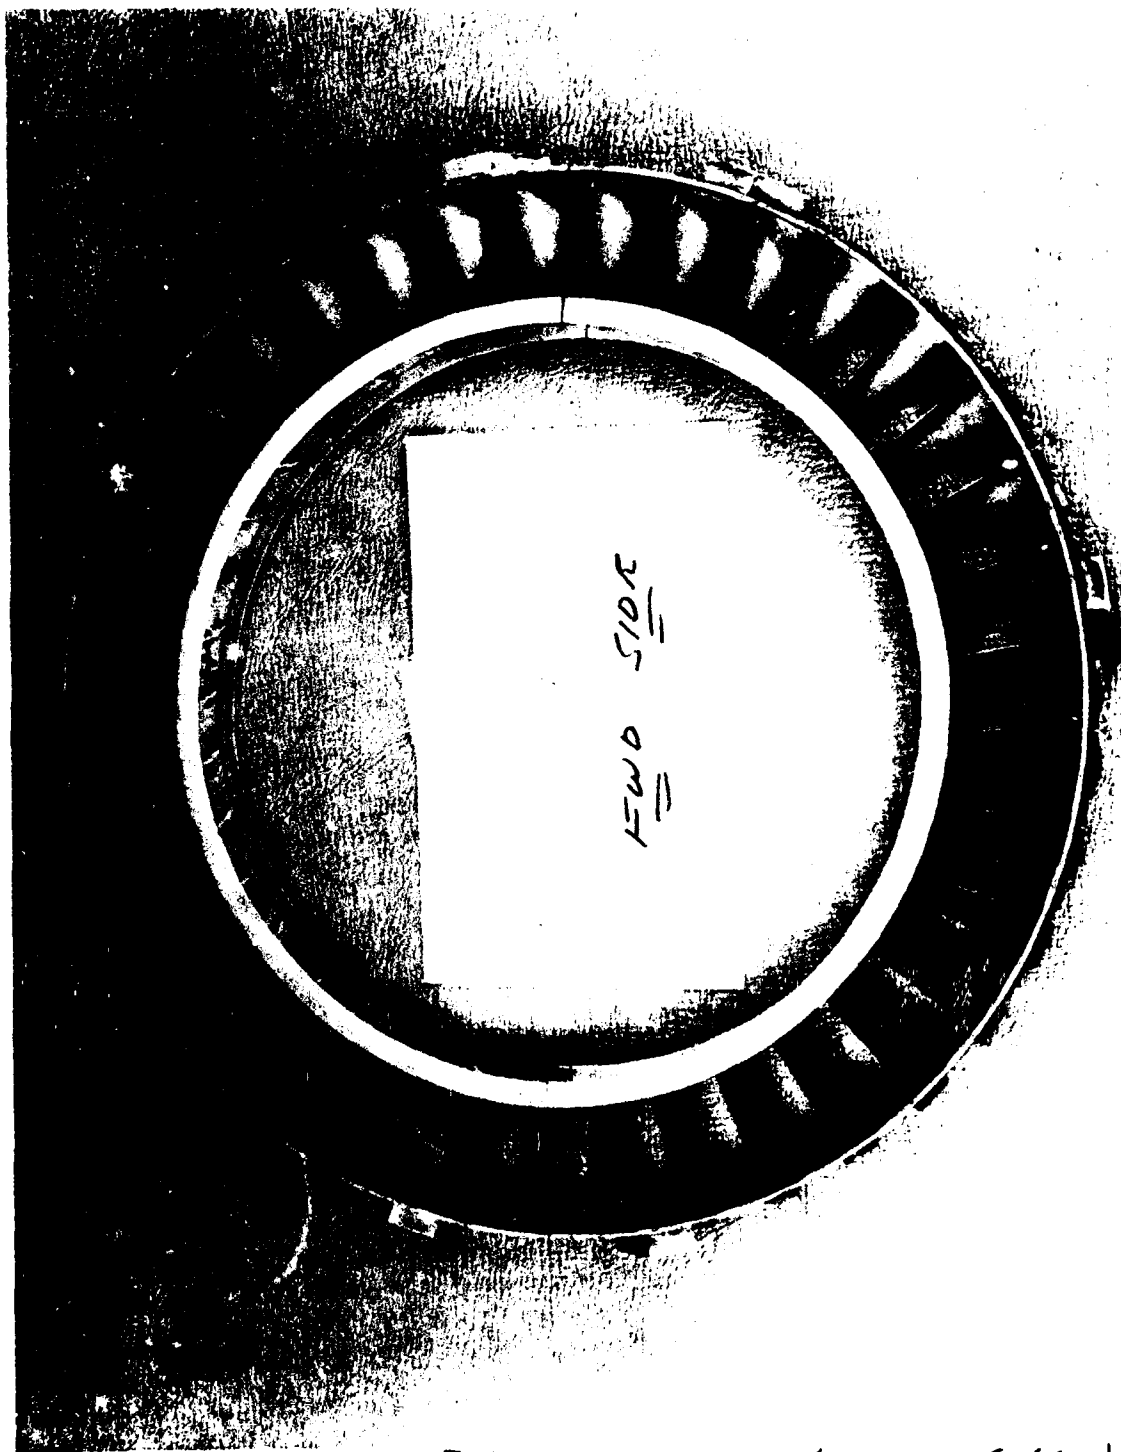
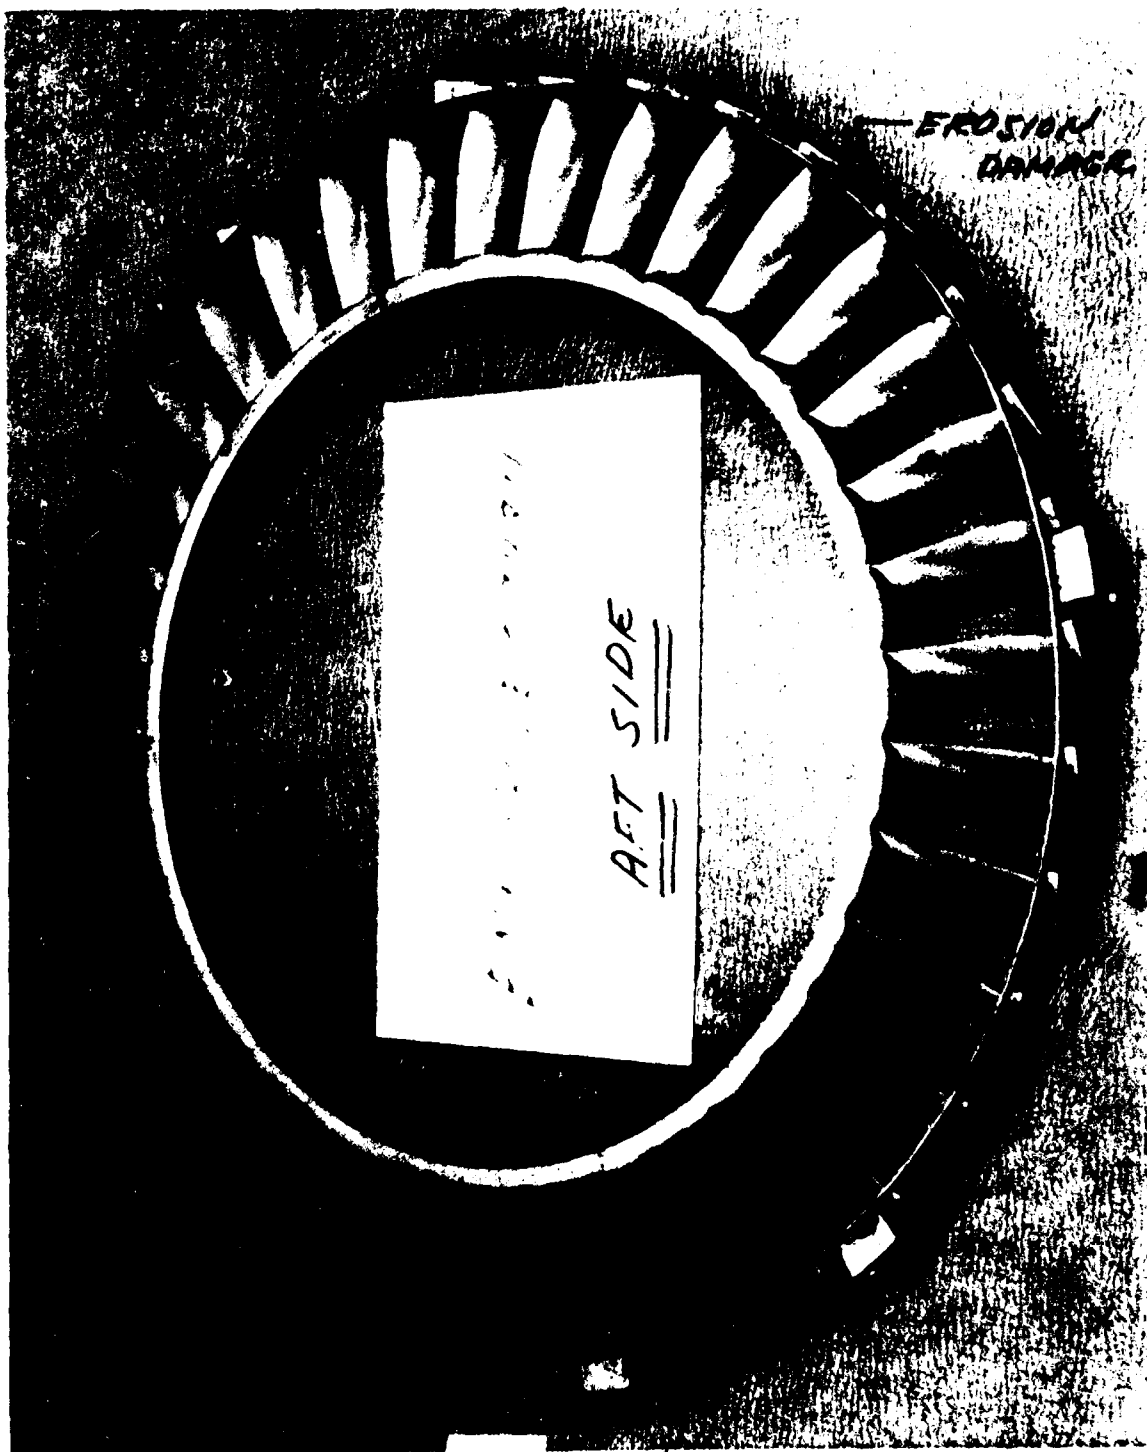
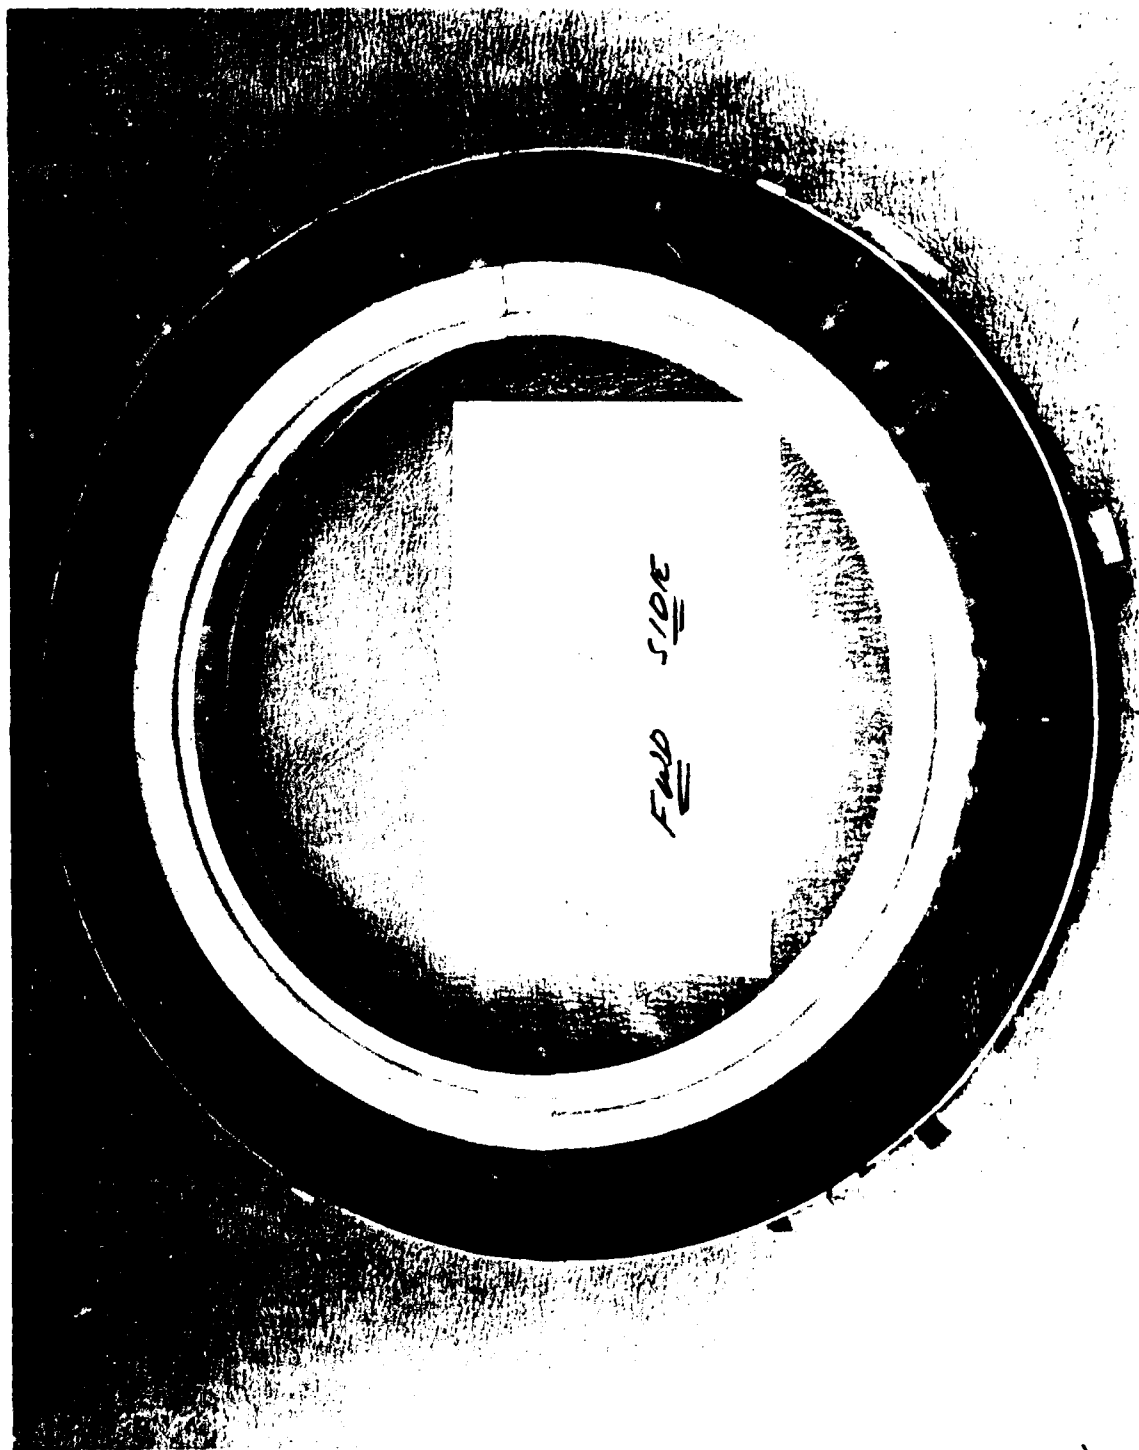
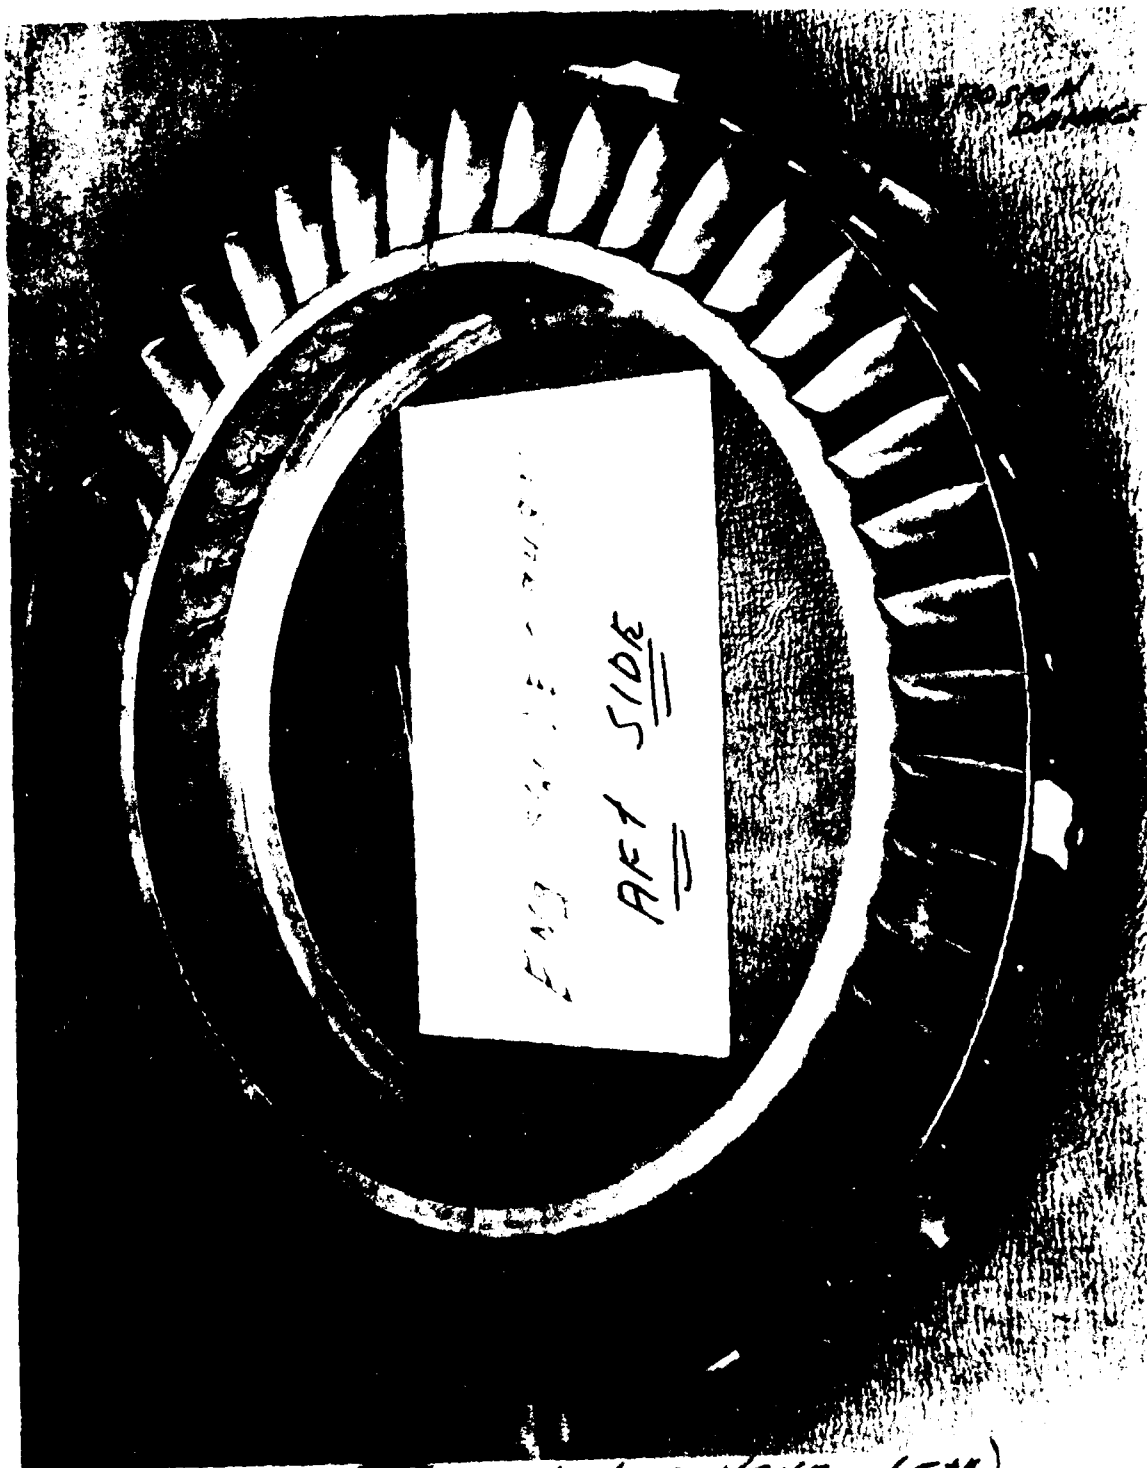
a. See inclosures VI thru XII which show the severe erosion damage on subject stator vanes. There is no criteria available to show whether these impeller vanes were new or used parts at time of test engine overhaul in Nov 66. Dimensional inspection has been accomplished after test. Should this data be desired, contact this writer.

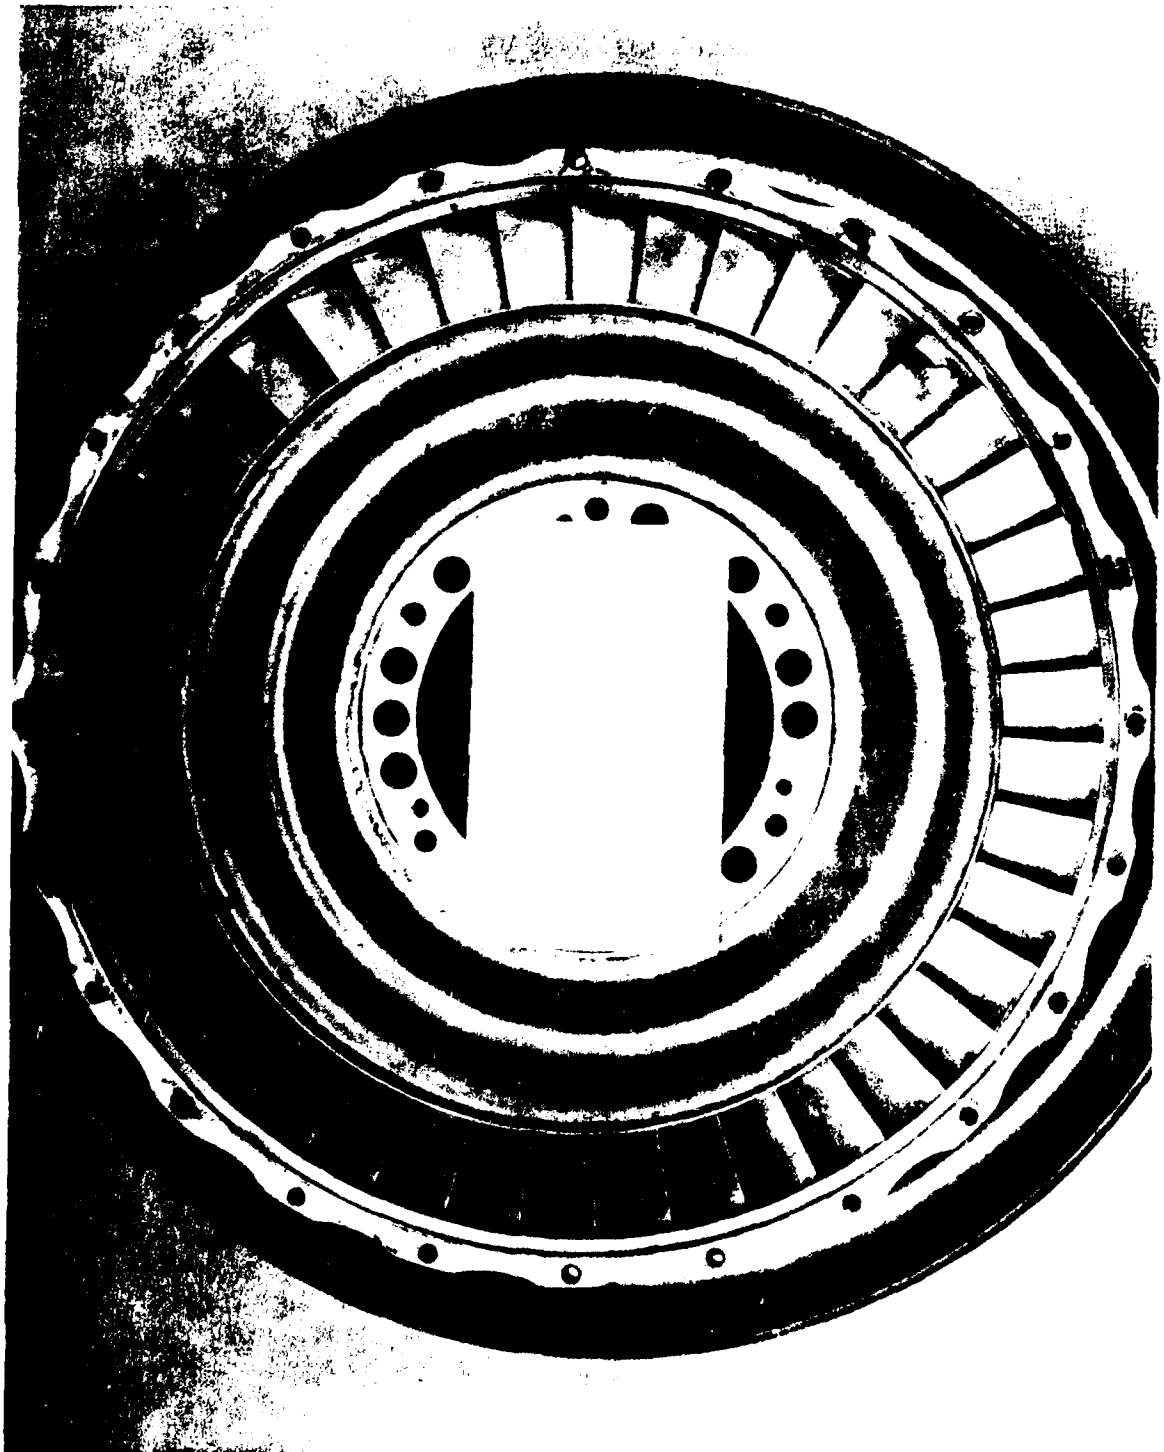
INCLOSURA INT. N. TURBINE 100015

a. The N1 turbine nozzle had two (2) burned vanes (See Inclosure XIII). This damage is sufficient to cause a noticeable degradation of performance. By replacing this turbine nozzle there is a strong possibility that this engine could have maintained overhaul test performance requirements. However, there is also the possibility that "tweaking" the engine in the field to make up for loss in performance caused by compressor erosion damage, has caused the higher than normal temperature that burned the vanes in question.
